February 14, 2007

HOME INSPECTION REPORT

101 Best Lane

Desirable, NJ

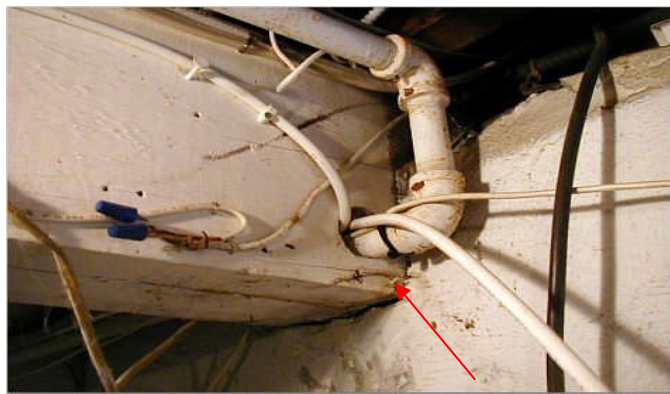
Drilled Beam has been Weakened

- Flooring throughout the home is adequately level and stiff.
- **A main beam end has been drilled for a pipe in a position which weakens the support.**

- **See separate wood destroying insect report from Terminite, Inc.**
- **Monitor the beam end where drilled for evidence of additional cracking or other failure. Install a support column at this weakened end of the beam if any additional cracking or movement occurs.**

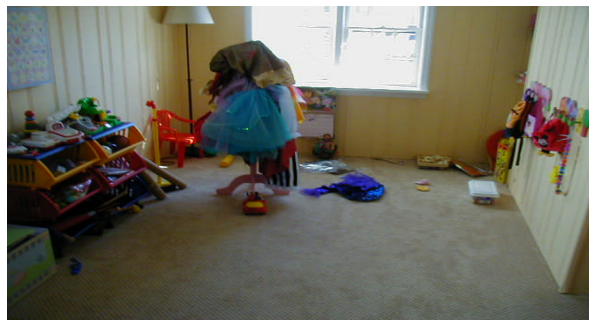
Note: Floor framing or support beneath the right front former garage room is not accessible or visible. This type of wood sleeper floor frequently sustains insect and water damage, due to the proximity of wood framing to grade level.

The right front room (den) is built on wood sleepers

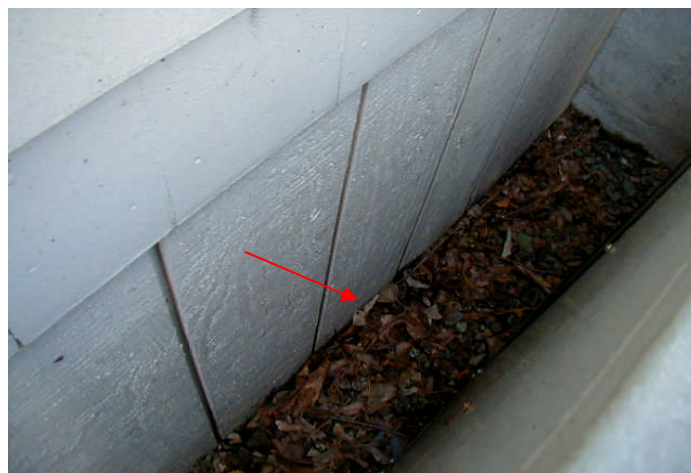
Back: Inadequate – a section of crawlspace at the right rear is surrounded by textured plywood, in contact with soil. This is conducive to wood destroying insect entry.

Plywood in contact with soil surrounding a crawlspace

- **Modification of arrangement and material surrounding right rear corner crawlspace, either with non-organic material, or so that wood does not contact soil.**

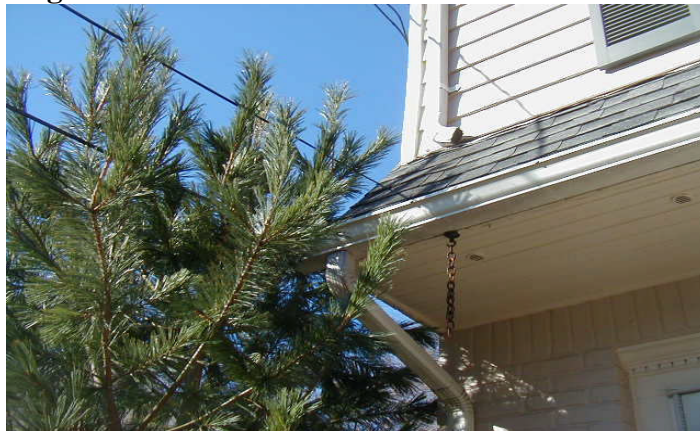
Landscaping Several trees and shrubs are very close to or in contact with the roof edge and siding. This is conducive to wood destroying insect entry, and could cause damage to the siding and roof.

Tree in contact with the house

- **Have trees and shrubs trimmed back so that they are no longer in contact with the home.**

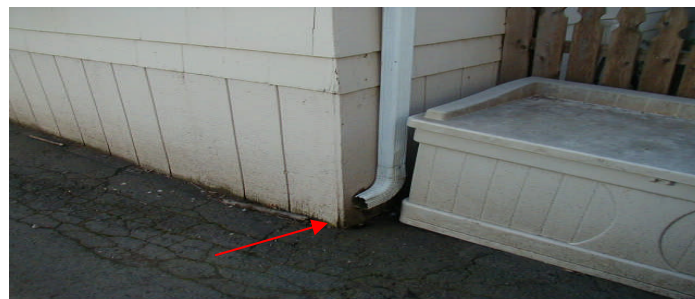
Some downspouts are not adequately diverted away from the base of the home. Some areas of the home, such as the central back section, may not have sufficient downspouts to adequately drain the roof.

Inadequately diverted downspout

- **Direct all downspout discharge points as far away and downhill from the base of the home as is practical.**
- **Monitor drainage from gutters during heavy rains, and have additional downspouts added as necessary.**
- **Consider extending upper downspouts all the way to the ground.**
- **Have the roof drainage system cleaned and maintained on a regular basis by a qualified gutter maintenance company.**

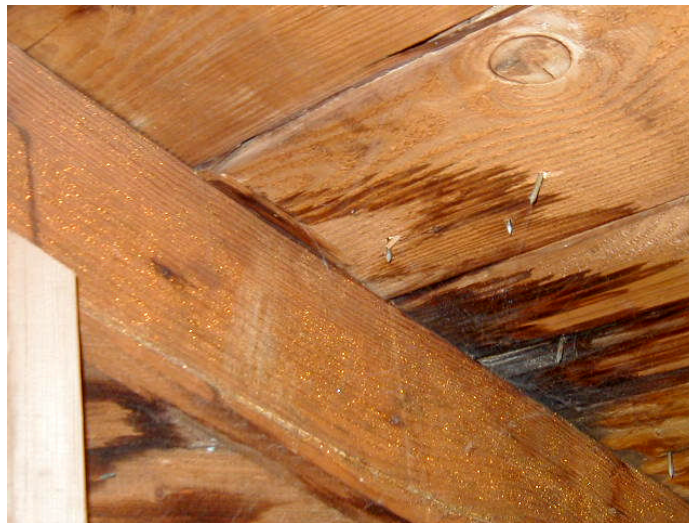
- Roof shingles appeared to be functional on the date of inspection.
- **Water staining was seen on roof sheathing, near the roof edges.**

Staining on roof sheathing at the roof edge

- **Have debris removed from the roof area around the skylights, and keep this area clear of debris in the future.**
- **Stains seen in the attic suggest possible leakage. Have the roof evaluated for leakage by a roofer, with repairs made as necessary to assure a leak free condition.**

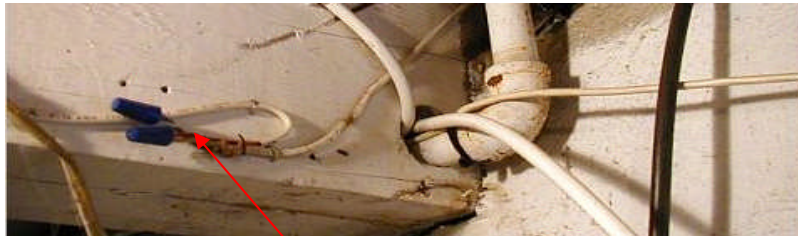
- **Some open unenclosed connections and/or junction boxes were found in the basement. This is a hazard.**

Hazardous Electrical Connections

- **Have a licensed electrician enclose all open junction boxes and any other exposed electrical connections.**
- **Have a licensed electrician install functional GFCI electrical outlets in all wet areas of the home including kitchens and bathrooms that lack them.**

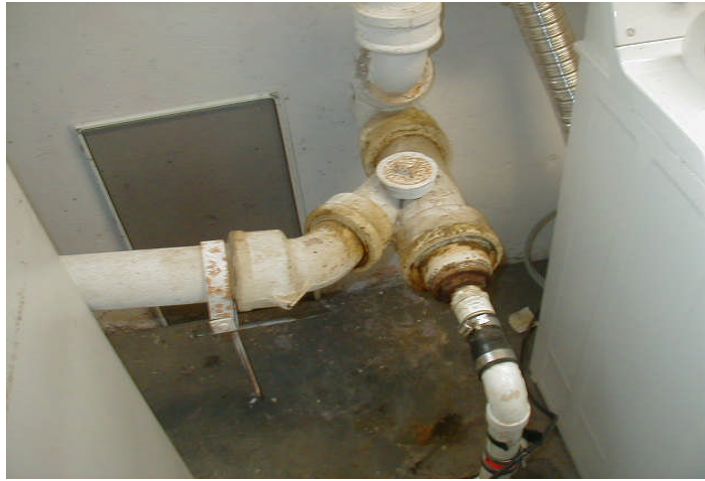
Condition: The sump pump discharges into the house plumbing drainage system. This may not be permitted by the local municipality. In addition, if drain plumbing, becomes clogged, the sump pump may back up and discharge water into the basement.

Sump pump discharging into drain plumbing

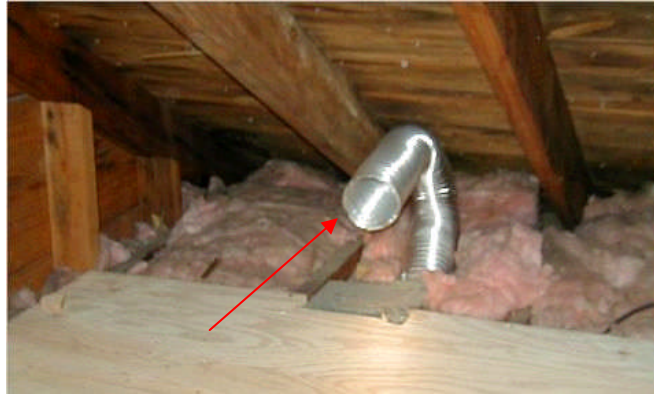
There is a vent discharging directly into the attic. Moisture from this vent can cause premature failure of the framing and roof.

Improper Venting into the Attic
