February 14, 2007

HOME INSPECTION REPORT

101 Best Lane

Desirable, NJ

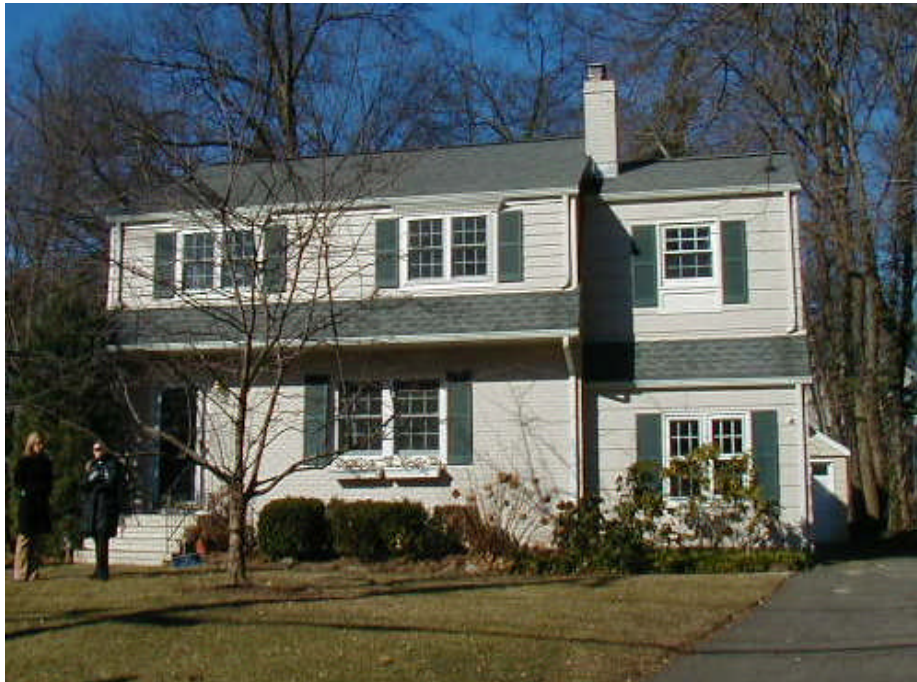
101 Best Lane, Desirable, NJ

Description of Property Wood frame, one family, two story home. The first floor has an entry hall, living room, dining room, kitchen, family room, den, and half bathroom. The second floor has four bedrooms and two full bathrooms. There is an unfinished basement beneath part of the home. There is a one car detached garage.
